Case Studies in Engineering Failure Analysis

Assessment of circumferential cracks in hypereutectic Al-Si clutch housings

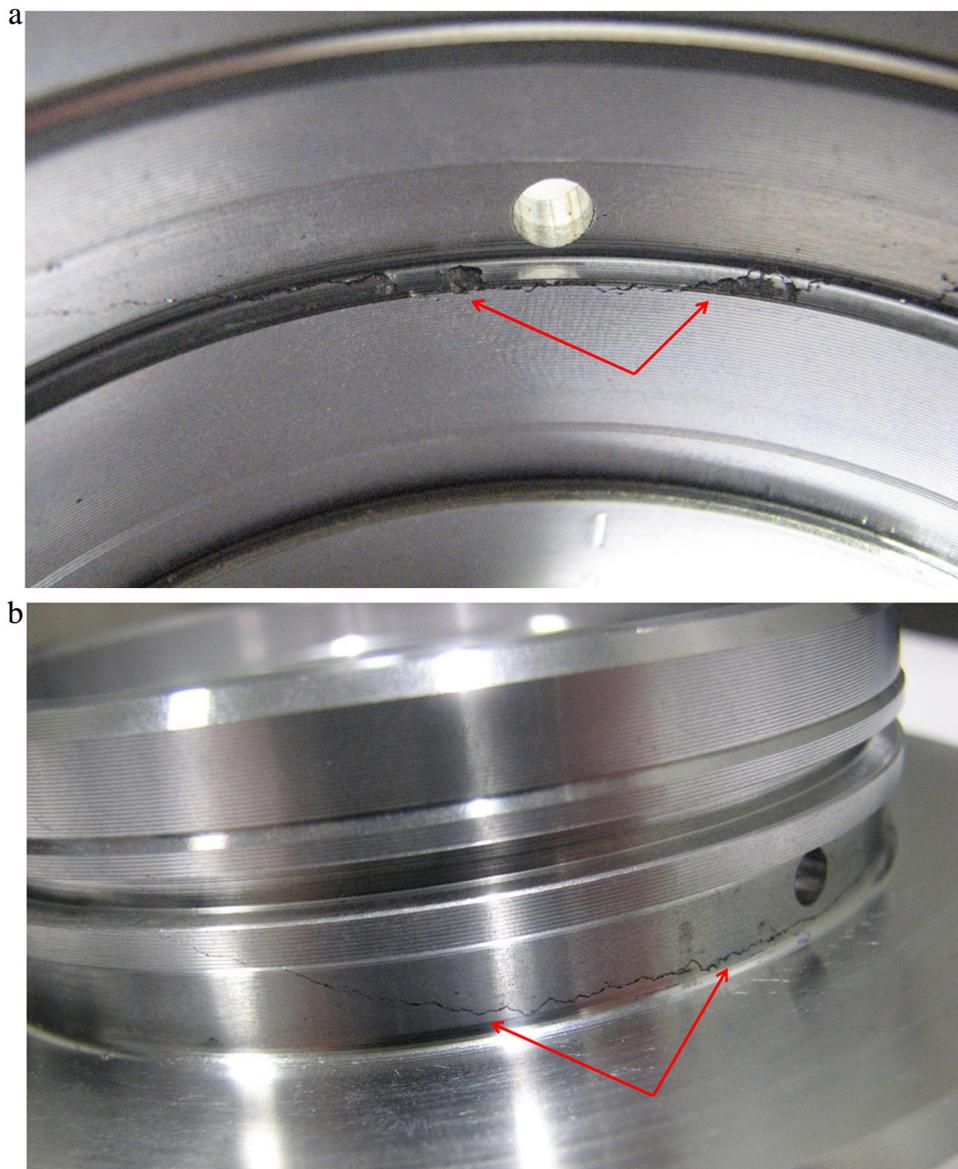
Fig. 2. The location of cracks on both sides; a) inside view of the crack, b) outside view of the crack. Red arrows show the crack path. Surface revealing crack is machined which made it possible to actually see the crack during the manufacturing process. (For interpretation of the references to colour in this figure legend, the reader is referred to the web version of this article.)

The failed part contains a single, wide crack running through the entire circumference of the part (Fig. 2). No sign of deformation is visible in the plate indicating that the failure occurred in a brittle mode. Fig. 3 shows the SEM microstructure and EDS analysis of different spots of the failed part which consists of aluminum matrix with silicon particles as reinforcing phase. The primary Si is those light gray regions while white phases are different types of iron-rich intermetallic compounds

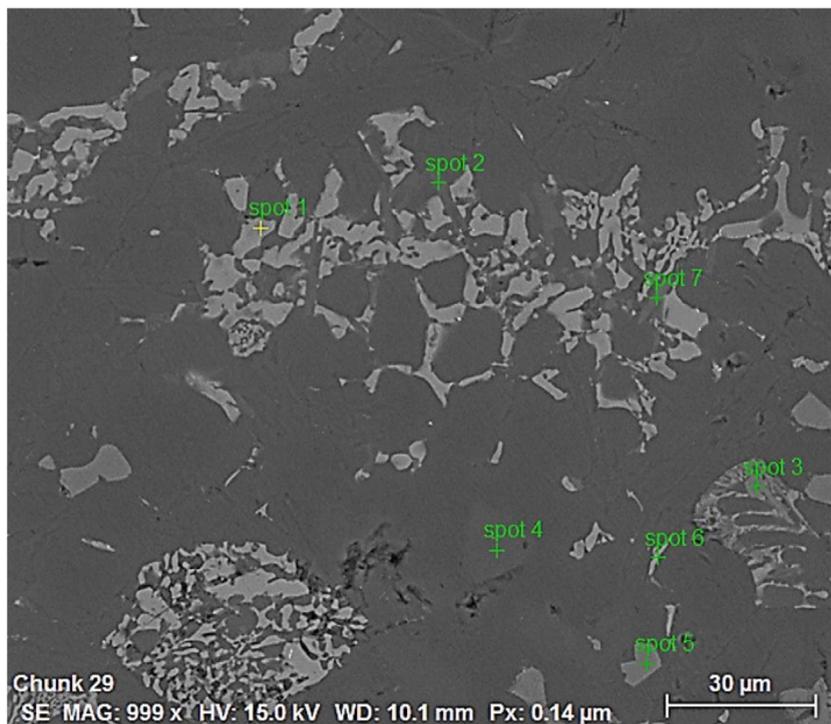
Fig. 3. SEM image of the cracked Al-Si alloy including EDS analysis results of different spots in the structure, wt%.

By doing point analysis through EDS different phases in the microstructure were individually analyzed. The corresponding compositions of the major elements are presented in Fig. 3. Dark colored phase in the microstructure corresponds to primary silicon particle while the composition of bright-colored phase is closely related to the Fe-rich intermetallic phase (i.e. Al_5FeSi).

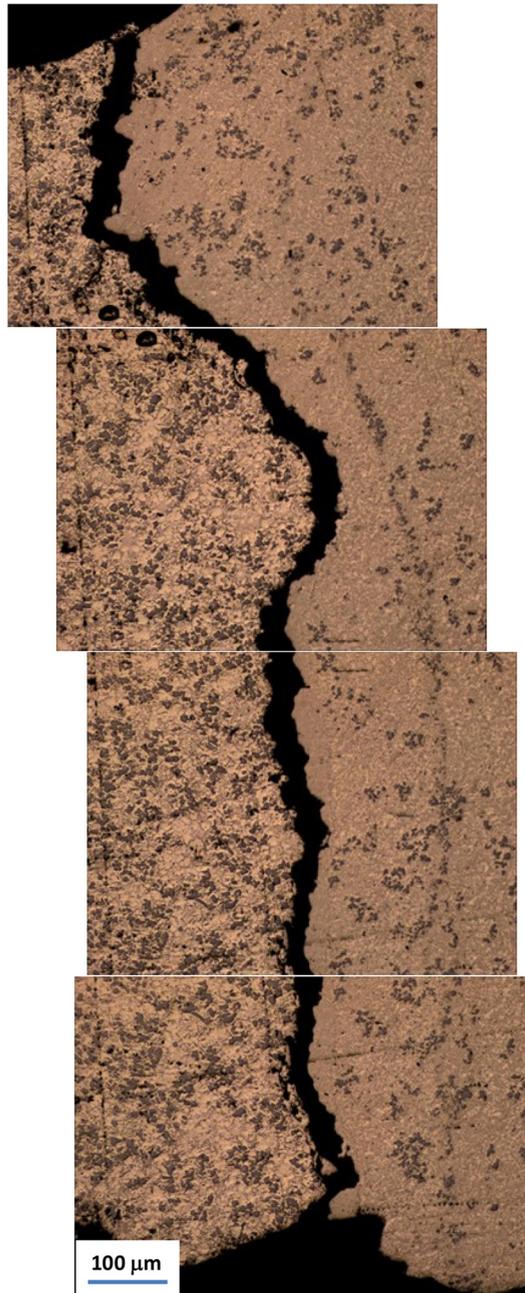
Fig. 4 shows the optical micrograph of the failed (cracked) part near the fracture surface. As seen, the microstructure of the alloy around the crack are quite different; in the left side, grains, Si particles, and intermetallic compounds are quite coarse, however, in the right side fine structure is observed.

Fig. 4. Optical micrograph of the through-thickness crack showing the crack path and surrounding structures.

Different grain sizes observed in Figs. 4 and 5, can be attributed to different cooling (and solidification) rates happened inside the die during casting process. Finer grain area corresponds with the higher cooling rate which is typical for surface solidification of metal. As the solidification time is shorter, less time will be available for the diffusion of the hydrogen into the inter-dendritic regions resulting in lower volume fraction of pores near the surface. Also, increasing the solidification rate reduces the time during which solid state diffusion state may take place which results in a lower concentration of Si in solid solution. These effects result in refinement of grains and phases (*i.e.* Fe-Si intermetallic compounds), modification of acicular eutectic Si, and suppression of detrimental precipitates [20]. It is reported that increasing the cooling rate causes a change in the morphology and magnitude of Fe-rich intermetallic (*i.e.* Al_4FeSi_2 , Al_5FeSi) compounds.

The left side of the crack includes large Fe-intermetallic compounds and coarse pro-eutectic Si phase revealing that the rate of cooling is quite slow. These coarse phases, formed at a slow cooling rate, are detrimental to the mechanical properties. However, on the right side with higher cooling rate, the solubility of Si in Al-matrix increases and density and distribution of pro-eutectic Si gradually decreases. Higher dissolution of Si content in Al-matrix results in the fragility of the alloy promoting the crack susceptibility.

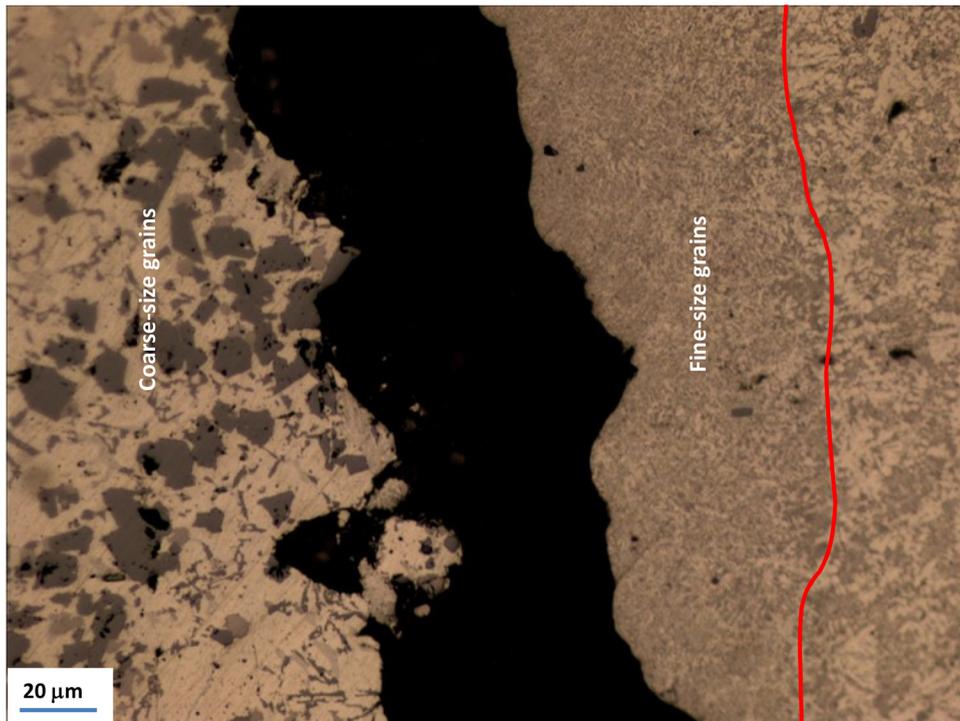
Fig. 5 shows the cracked region at higher magnification. From left to right the microstructure can be divided to (i) coarse-sized structure, (ii) crack, (iii) fine-grained structure, and (iv) medium-grained structure. Some gas porosities are also visible in Fig. 5. These defects act, at a minimum, to decrease the load bearing cross section and as crack nucleation sites.

Fig. 5. Higher magnification of the crack and the surrounding structures including coarse, fine, and medium grain size. Red line is the border between fine and coarse grain sizes. (For interpretation of the references to colour in this figure legend, the reader is referred to the web version of this article.)

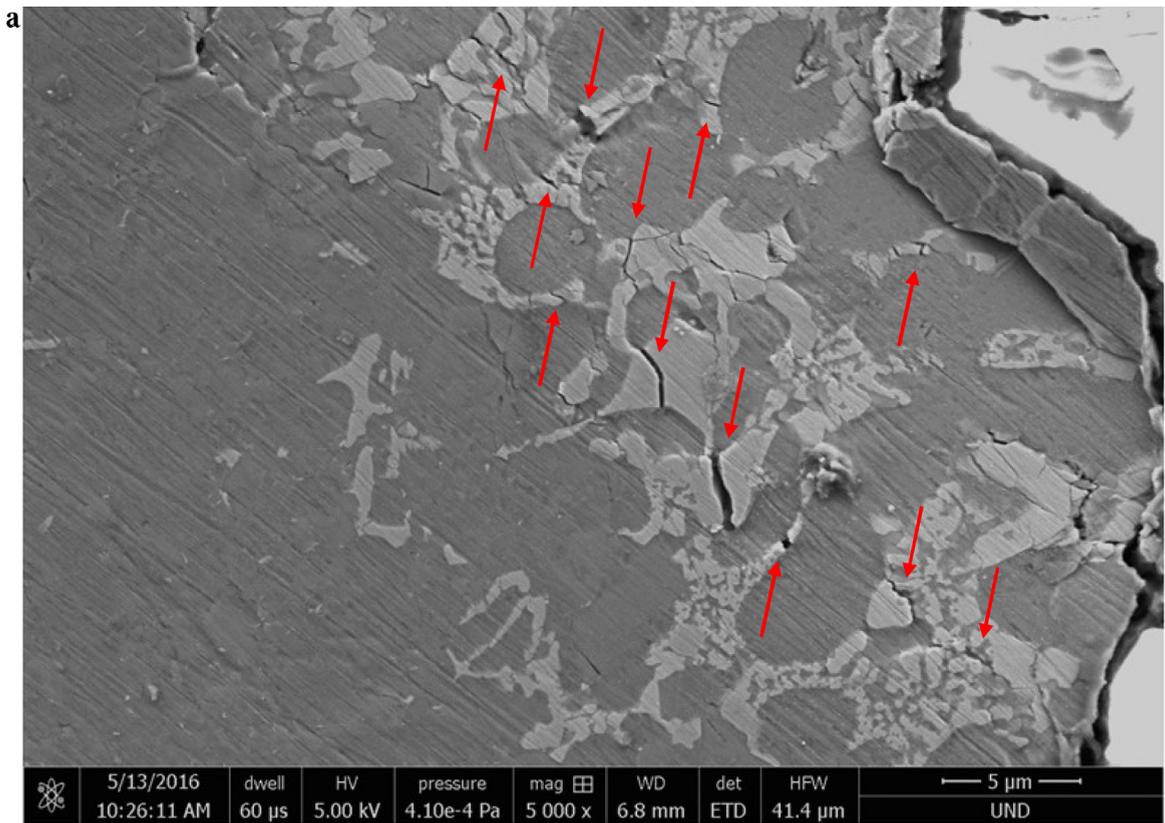
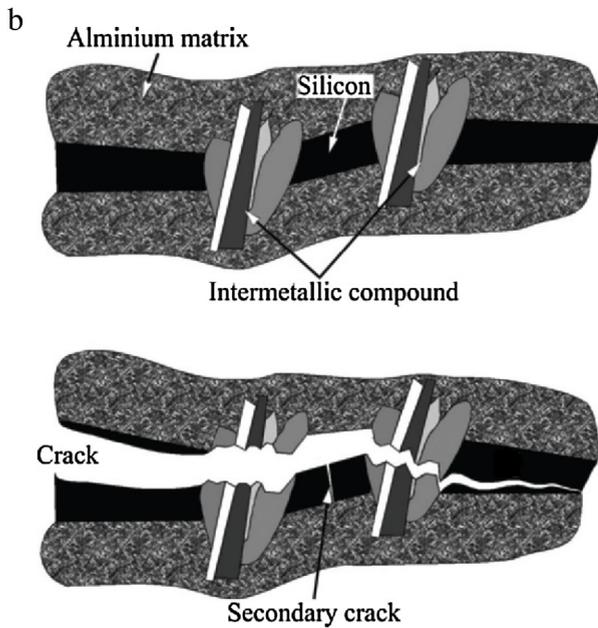
Beside a primary through crack, some secondary cracks in silicon particles and Fe-rich intermetallics are also visible along with the principal crack and are mostly confined along the silicon particles (Fig. 6a). These cracks are shown with a red arrow in Fig. 6a. Under applied external stresses during manufacturing (*i.e.* machining) or service, Al matrix experiences plastic deformation around Si platelets (and Fe-rich particles) resulting large stress mismatch and stress concentration which reduces the toughness and crack resistance of the component. Indeed, tips and terminals of these hard (and brittle) phases act as stress riser points upon which crack nucleates in the Al matrix and propagate through hard and stiff phases (Si and

Fig. 6. a) cracked Si particles and Fe-rich phases along with the principal crack, b) Schematic illustration of the fracture mechanism including starting microstructure of Al-Si alloy and propagation stage of crack along Al-Si interfaces and breakup of blocking intermetallic particles [25].

Fe-rich) upon loading (Fig. 6b) [6,23]. It worth noting that the presence of these secondary cracks weakens matrix (de-bonding of the silicon/Fe-rich particles from the matrix and propagation (coalescence) of cracks through cleavage of these brittle phases) and thus more tight control of solidification rates is extremely important.

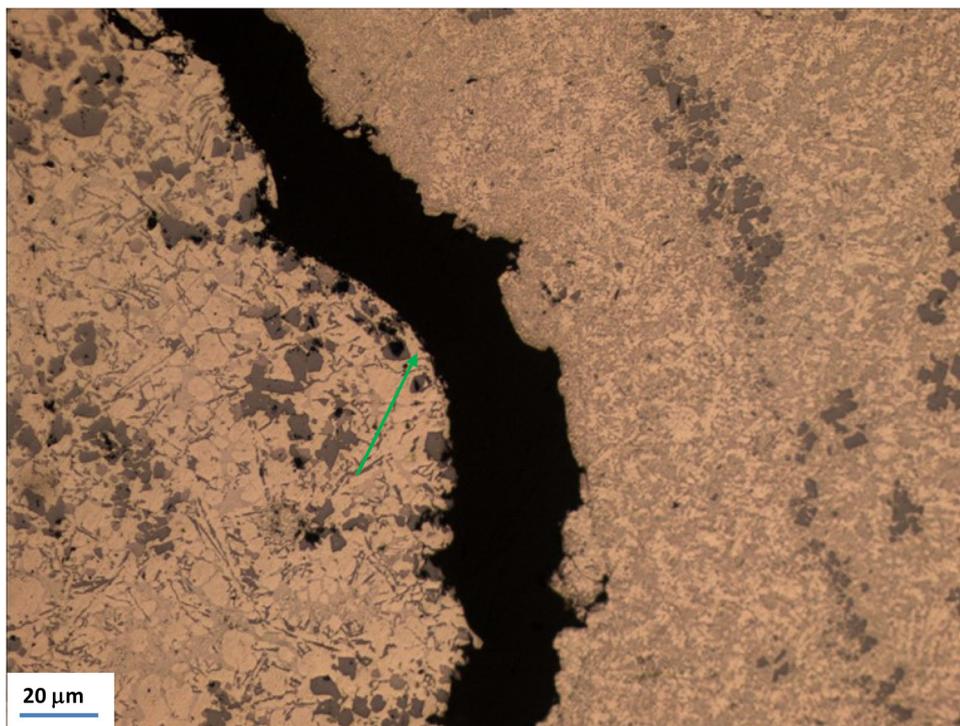
During actual service, cracks are initiated in the silicon particles or at the interface of Si particle and aluminum matrix, then the damage grows and micro-cracks are formed. These micro-cracks then link to each other and crack propagates (Fig. 7). In Al-Si alloys, crack initiation mainly occurs due to stress incompatibility and low bonding strength between ductile aluminum matrix and brittle Si particles. Due to de-bonding between Al and Si, micro-voids are formed at the Al/Si interface; then these micro-voids may interconnect to each other within actual service under applied stresses/strains and form the principal macro-crack [24]. Sometimes the fracture is dominated by the iron-rich intermetallics, and Si particles. In hyper-eutectic Al-Si alloys, the fracture seems of an intergranular failure mode where coarse pro-eutectic Si particles and Fe-rich intermetallic compounds are present. Iron possesses very low solubility in aluminum and this results in the formation of various Fe-rich phases (*i.e.* spots 2, 3, 5) which are hard and brittle. Therefore, these phases tend to have a relatively low bond strength to the matrix resulting in co-participation of these iron-rich intermetallics and the Si particles in the damage events. For engineering applications (where ductility and toughness are critical), the Fe-content of the alloys should be kept at a minimum level Fig. 7.

Fig. 7. The crack and the structure around it. On the left hand side the surface of the solidified melt is smooth (green arrow). This is an indication of absence of fusion. Crack formation usually results in a rough surface on opening. This is because of the way crack propagates. The smooth surface, in this case, can only come from molten metal and it will be representative of solidified surface of the melt. It is always smooth – surface tension of melt. (For interpretation of the references to colour in this figure legend, the reader is referred to the web version of this article.)

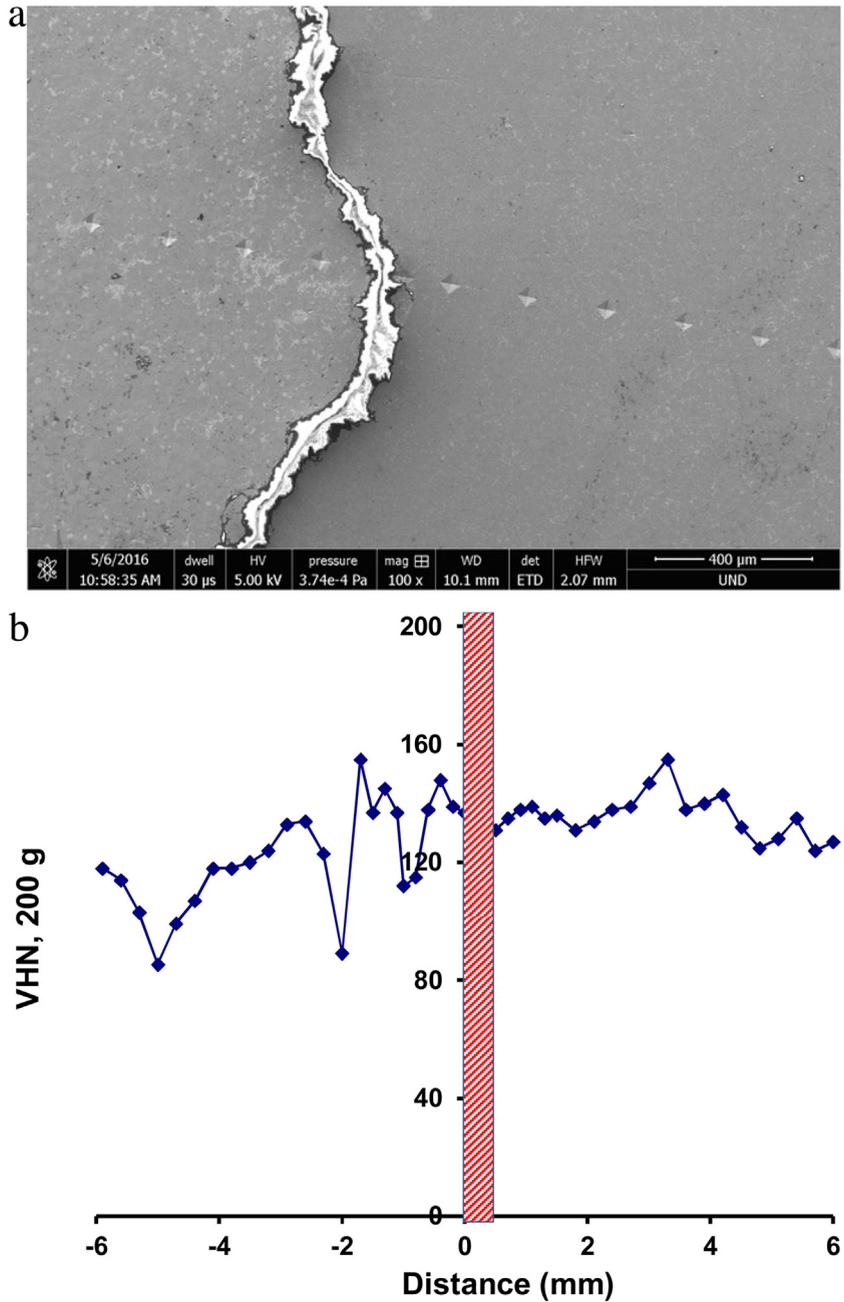
To measure the hardness variations in the cracked region Vickers hardness testing with 200 gf load was used. Fig. 8a shows the indentation prints around the cracked region and Fig. 8b shows the corresponding variation in hardness (hatched area corresponds to crack path). As seen, on the left side of the crack in which coarse particles are present, large variations in

Fig. 8. a) Vickers indenter prints on the cracked face, b) corresponding variations in hardness (the distance is measured from the crack).

hardness points exist; however, less scatter in hardness points is seen on the right side of the principal crack path where particles are finer and more evenly distributed.
